99-9223 Volvo S60 / V70

● DASH DISASSEMBLY

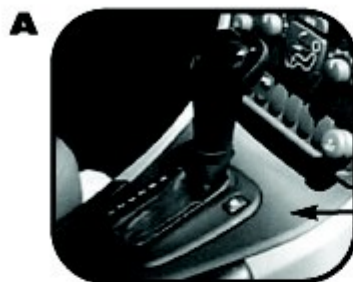
See figure A

- 2** Unsnap gearshift trim bezel and slide back.

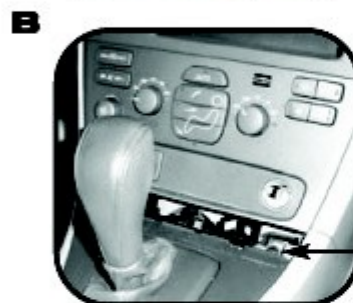
See figure B

- 3** Remove (2) T-25 Torx from climate control assembly, proceed to unsnap assembly from radio bottom.

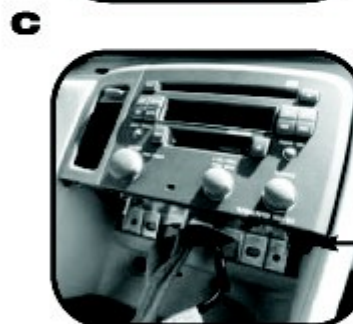
See figure C

- 4** Remove (2) T-25 Torx from radio bottom in climate control cavity to remove radio.
