## **2003-2005 VOLVO XC90**

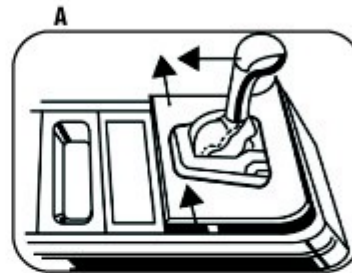
**2** Move the shifter to the rearmost position, unsnap the shifter trim and move it to one side. (Figure A)

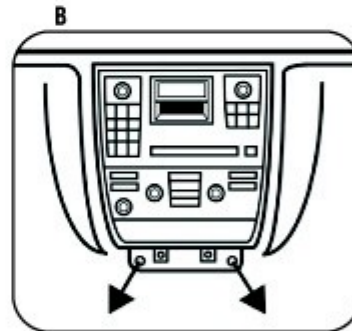
**3** Remove two screws from bottom of the radio/ climate control cluster. **CAUTION:** Do not remove connectors before turning the ignition off. (Figure B)

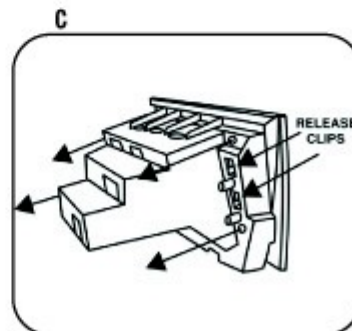
**4** With radio and climate controls out, remove four screws holding the radio to the bracket, release the clips and remove the radio. (Figure C)
